# **Field Demonstration of Condition Assessment Technologies for Wastewater Collection Systems**

**Kathy Martel, P.E.  
The Cadmus Group, Inc.**

**National Risk Management Research Laboratory  
Office of Research and Development  
U.S. Environmental Protection Agency  
Cincinnati, Ohio 45268**

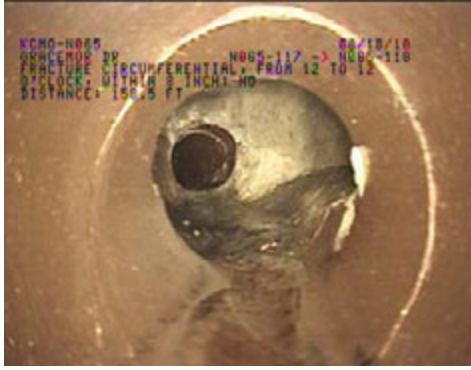
(a) Circumferential Fracture, Grade 2 Defect

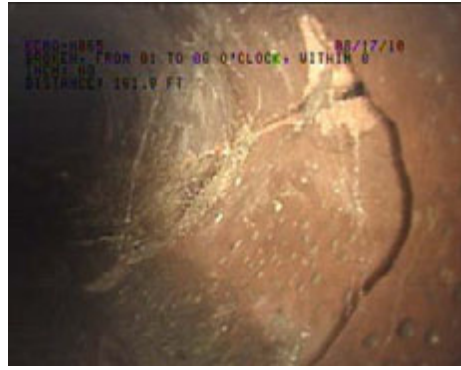
(b) Broken Pipe, Grade 5 Defect

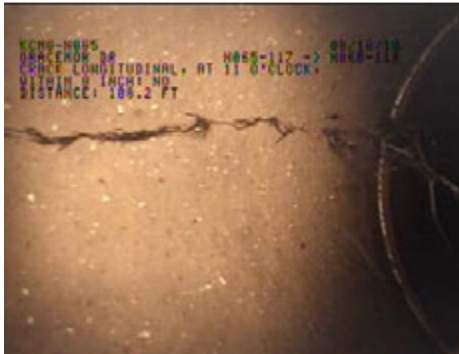
(c) Longitudinal Crack, Grade 2 Defect

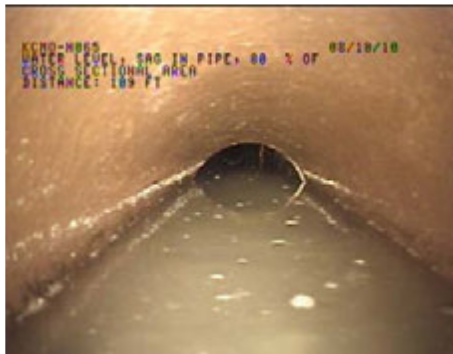
(d) Pipe Sag, Grade 5 Defect

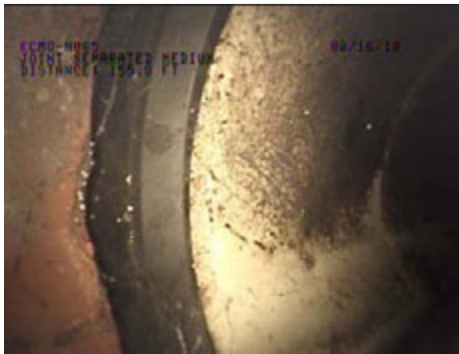
(e) Separated Joint, Grade 1 Defect

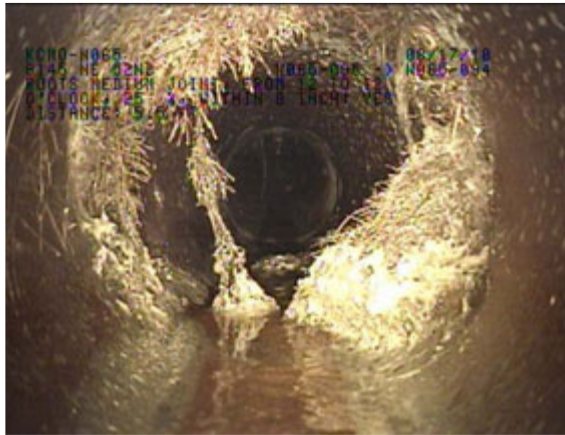
(a) Root Intrusion, Grade 3 Defect

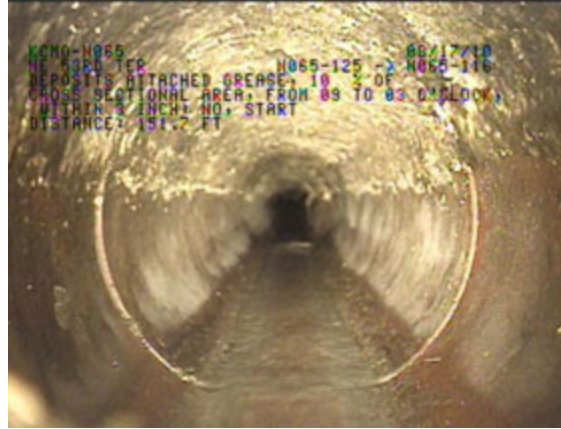
(b) Grease Deposit, Grade 2 Defect

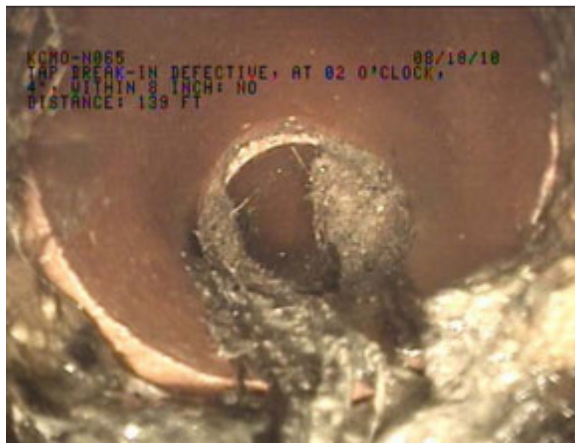
(c) Defective Tap, Grade 3 Defect

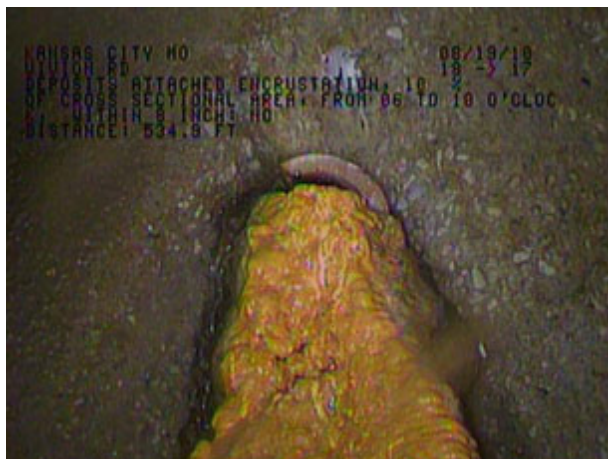
(a) Encrustation Grade 2 Defect

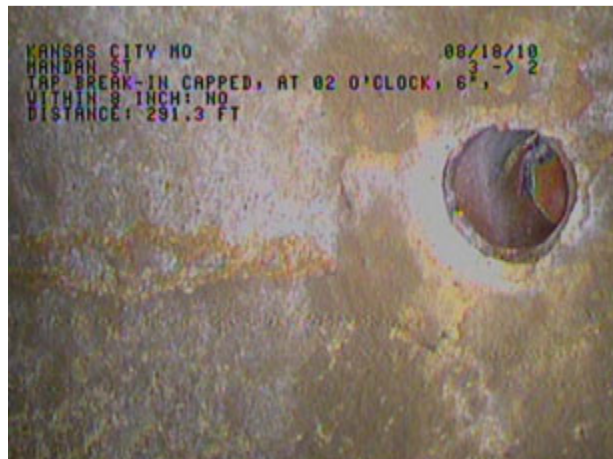
(b) Damaged Service Tap, Grade 2 Defect

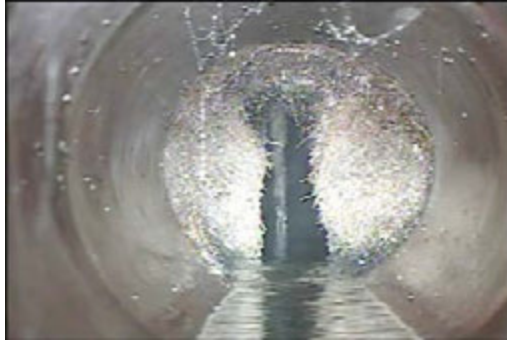
**Figure 5-4. Grade 4 Root Intrusion (Maintenance Defect) in MH 100-101  
Identified from Zoom Camera Images in the Gracemor Area.**  
(Photos Courtesy of TREKK Design Group)

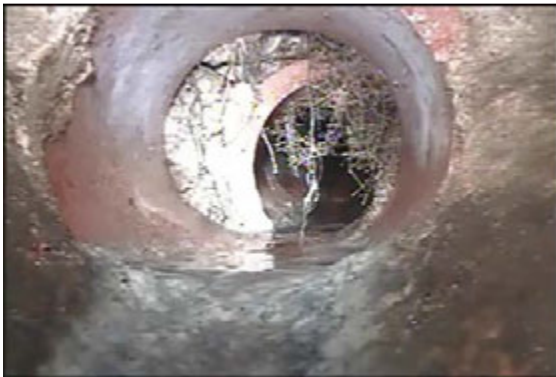
(a) Grade 2 Off-set joint in MH 136-137

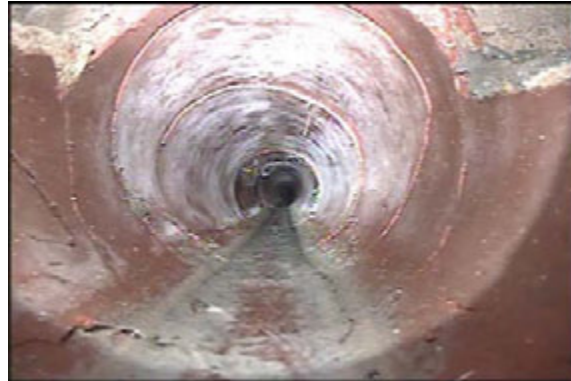
(b) Grade 2 Circumferential Fracture in MH 125-127

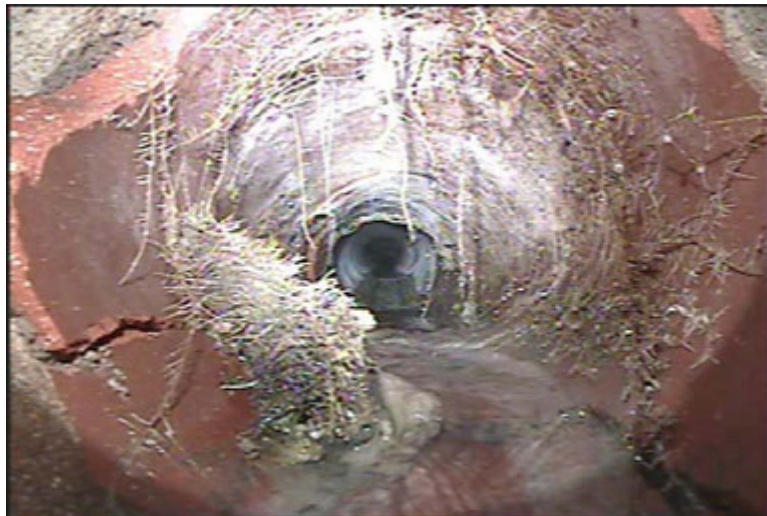
(c) Grade 3 Broken Pipe in MH 127-128

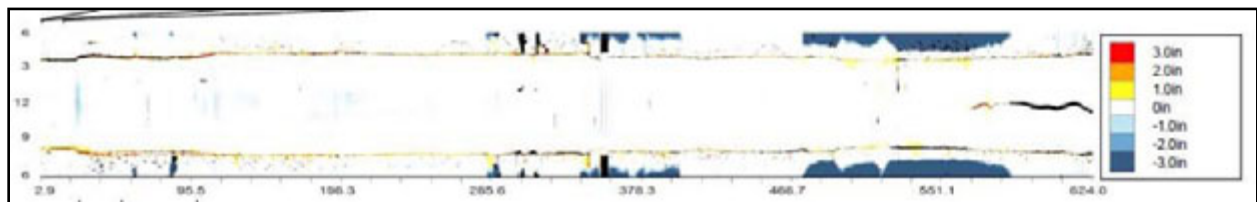
**Figure 5-12. Flat Graph™ for Pipe Segment from SMH 1- 18.**

Figure 5-12 provides an example of the Flat Graph™ for the pipe segment between SMH 1 and 18. The graph shows that debris, as denoted in dark blue, had accumulated to a thickness of 3-in. at the invert location (i.e., six o'clock) between 470-ft and 580-ft downstream of SMH 1. Figure 5-12 also shows that corrosion loss of approximately 1-in., denoted in yellow, occurred at the same location.

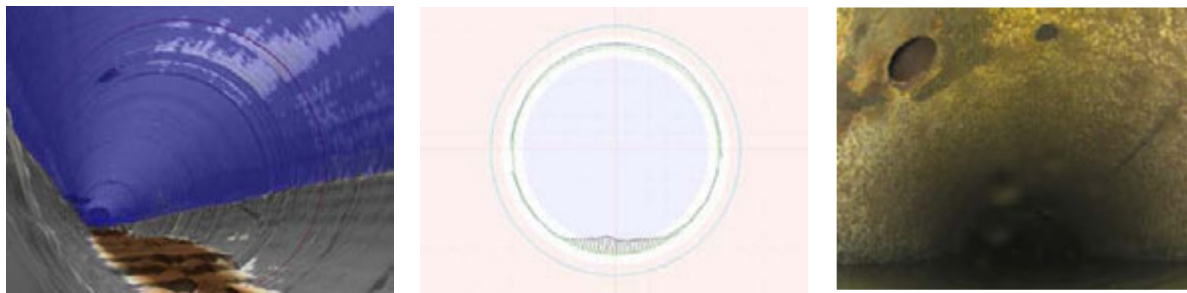
A more detailed view of the pipe cross-section is provided by three distinct images (Figure 5-13) at the same location along the pipe (approximately 516-ft to 518-ft downstream of SMH 1). Together, the images show location and cross-sectional area of debris and corrosion loss, and a service connection at the pipe crown.

(a) 3D image at 518.1-ft      (b) cross-sectional graphic at 517-ft      (c) HD image of the pipe crown at 516.5-ft.

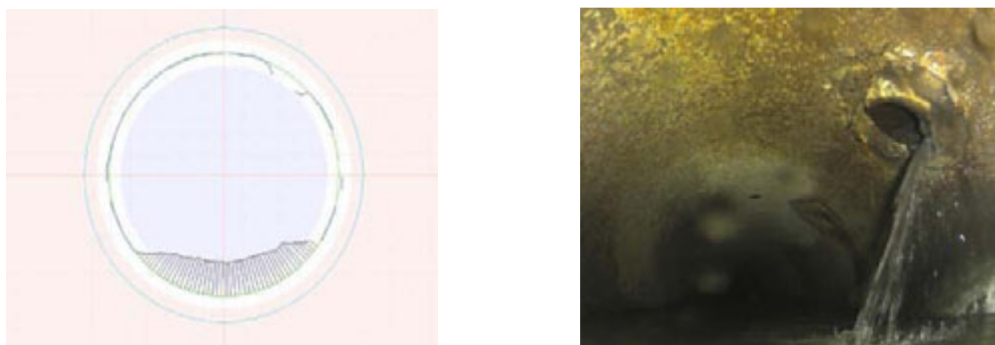
In a similar manner, other notable defects (e.g., protruding lateral) can be reviewed using the cross-section graphic and HD image as shown in Figure 5-14.

**Figure 5-14. Cross-Sectional and HD Images of 2.5-in. Protruding Lateral at 528.4-ft.**

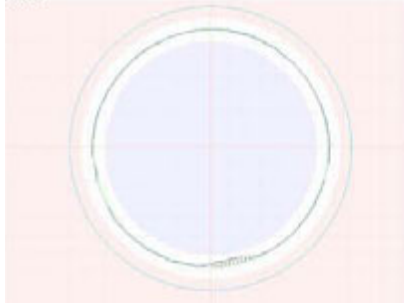
0ft General Observation - Corrosion to 0.5", Debris to 0.9"

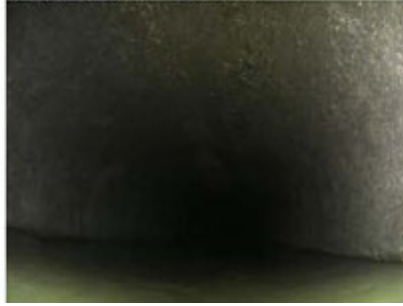
0ft General Observation - Debris to 0.9"

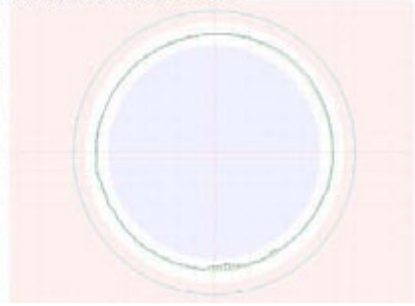
18.7ft Maximum Corrosion - To 0.8"

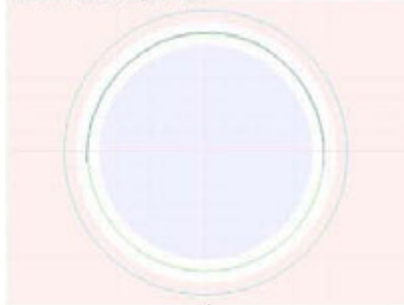
0ft General Observation - Corrosion to 0.5"  
No sonar data throughout run

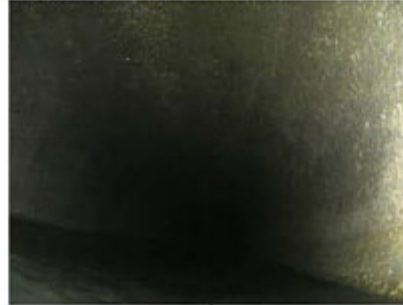
0ft General Observation - Corrosion to 0.5"

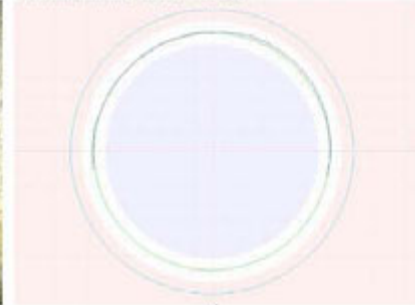
18.1ft Maximum Corrosion - To 0.8"

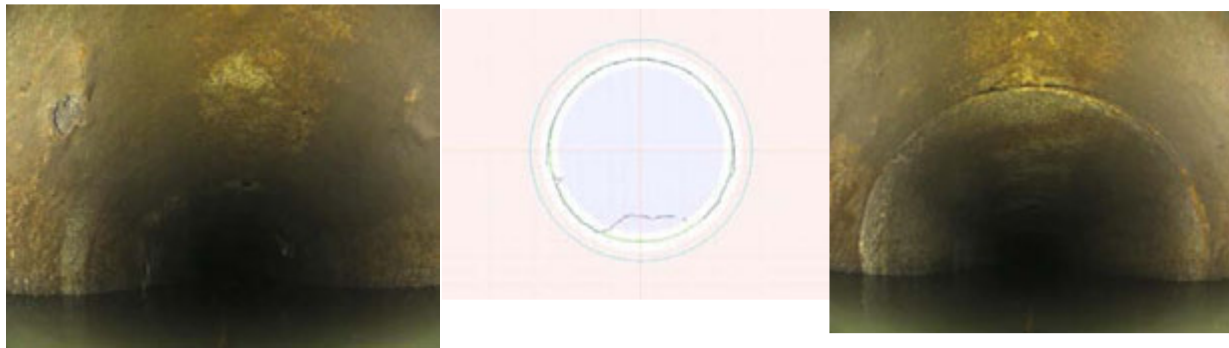
**Figure 6-14. Images from Multi-sensor Inspection 148-ft to 150-ft Downstream of MH 2 (left) Evidence of Delamination, (middle) Cross-Sectional View of Debris Accumulation; and (right) Corrosion at Pipe Crown.**

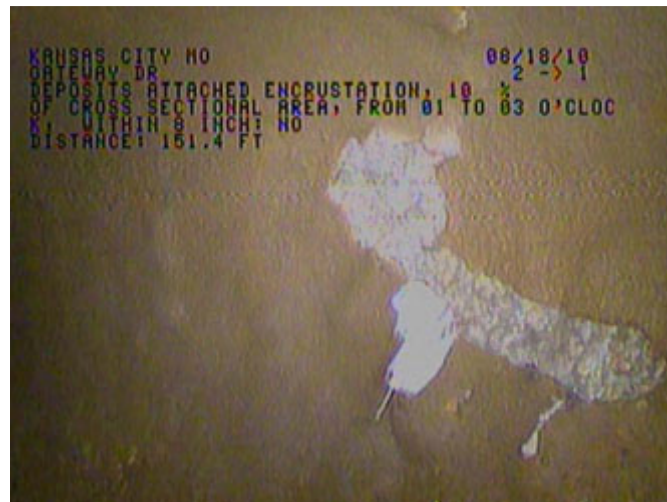
**Figure 6-15. CCTV Data 150-ft Downstream of MH 2 Showing Encrustation Deposit.**
